**Re: Compliance Evaluation Inspection  
Guanica Wastewater Treatment Plant  
NPDES Permit Number PR0020486**

## **NPDES Inspection Report**

### **COMPLIANCE EVALUATION INSPECTION**

Facility Name: Guanica WWTP  
NPDES Permit Number: PR0020486  
Permit Status: Administrative Extended (12/01/2008 – 11/30/2013)  
Renewal Application (05/2013)  
Date: June 19, 2017  
Time: 8:40 am – 1:10 pm  
PRASA Representatives: Amalio Quiros, Plant Operator  
Ivette Irizarry, Plant Manager

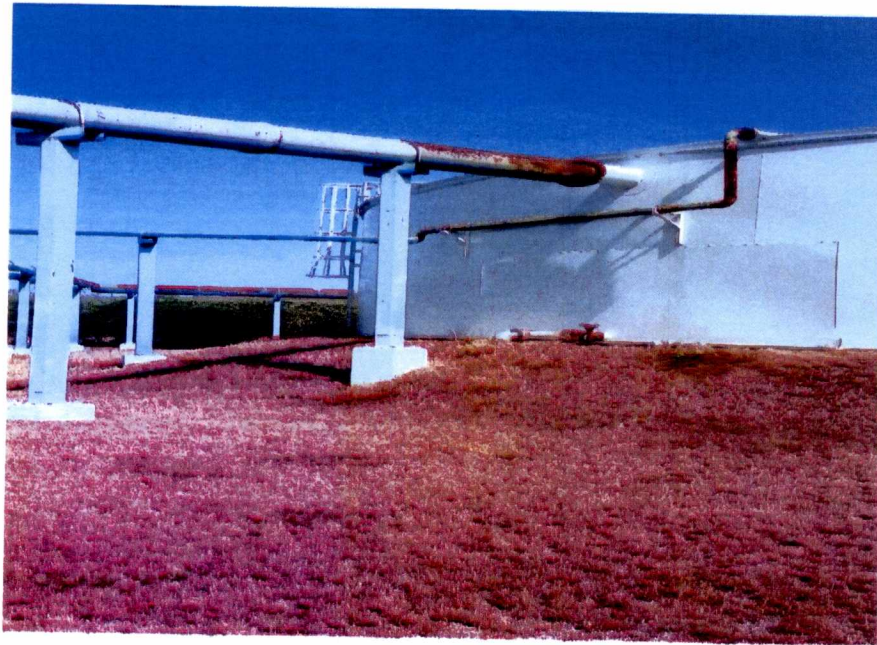
Guánica Waste Water Treatment Plant (CEI)  
June 19, 2017  
Figure # 4 – Partial view of corrosion at the plant.

Corrosion throughout the facility was observed. Figure # 4 attached shows a partial view of corrosion at pipelines.
